CREVICE CORROSION IN BOLTED LAP JOINTS MADE OF WEATHERING STEELS

Dagmar Knotkova¹, Jiri Steinbauer², Anna Kupilikova¹

Weathering steel, transmission tower, crevice corrosion, recovery protective system, laboratory and field tests

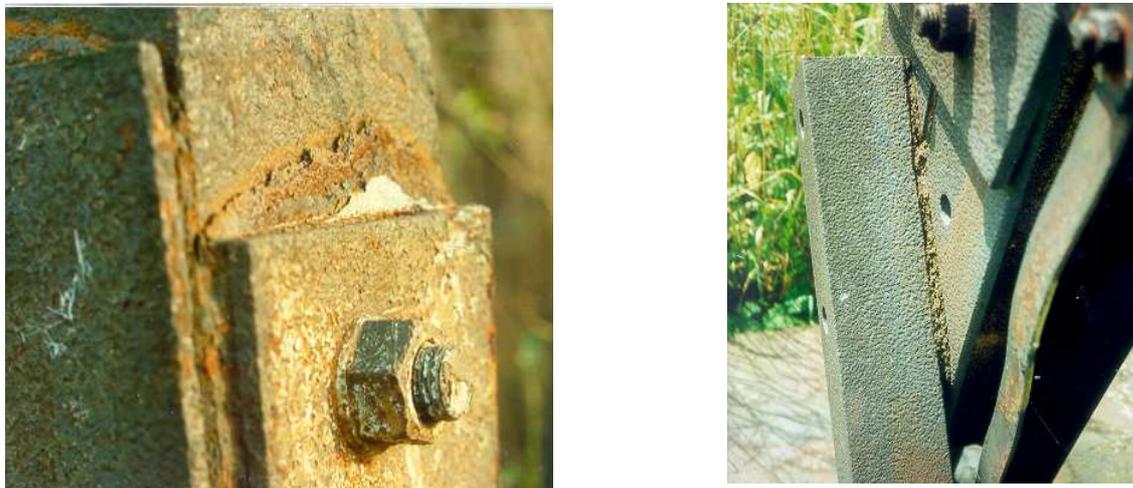
Figure 1 - Typical crevice defect

Proposals for the use of weathering steels for various types of steel structures are based mainly on the results of field corrosion tests in which significantly higher corrosion resistance of weathering steels has been proved compared to plain carbon structural steel. The corrosion rate of free surfaces cannot be fully transferred to expected corrosion rate on surfaces of structural elements (1, 2). Significant defects which may even cause deformation of joints were found in crevices in bolted joints of certain design exposed to more corrosive environment (Figure 1) (3, 4, 5).

The worse corrosion condition in bolted joints are characterized by accumulation of water during condensation and rain periods. Water then penetrates into the joint together with corrosive

components of the atmosphere. Drying is hindered as well as elution of corrosive rust components so that the periodic scaling of the upper rust layer does not take place.

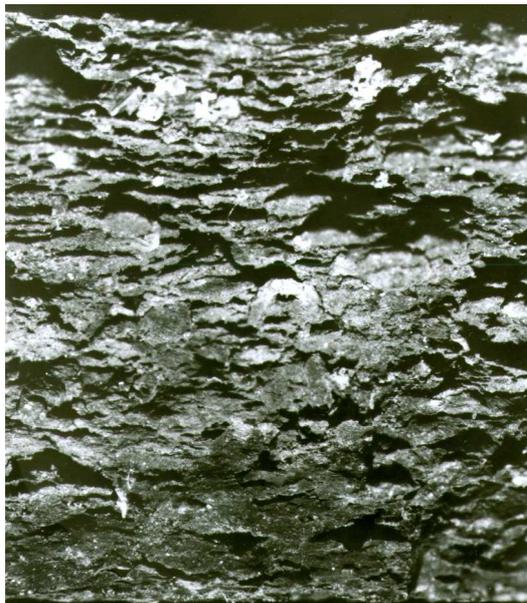
Figure 3 - Rust layers from crevices

Metallographic analyses show a different type of rust inside the crevice than that of the rust outside. Inside the crevice the rust seems more compact than outside on the open surface. The rust grows from the steel surface and later the rust layer becomes fused. The compactness and visual uniformity of rust inside the crevice gives evidence about the process stabilization and the limited effect of outside conditions (Figure 3).

macro photo

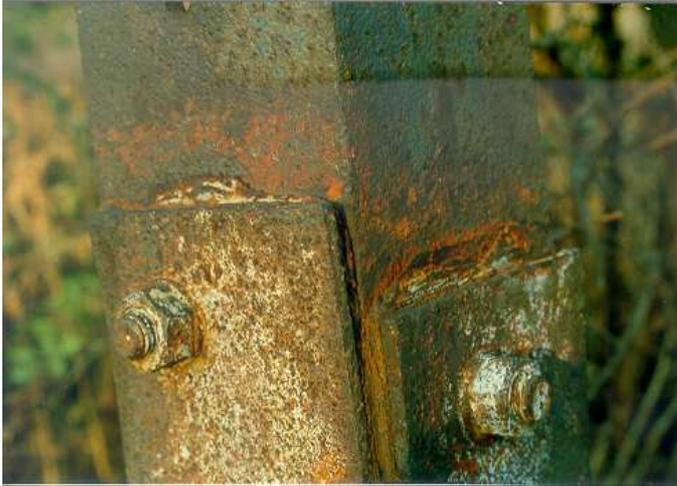
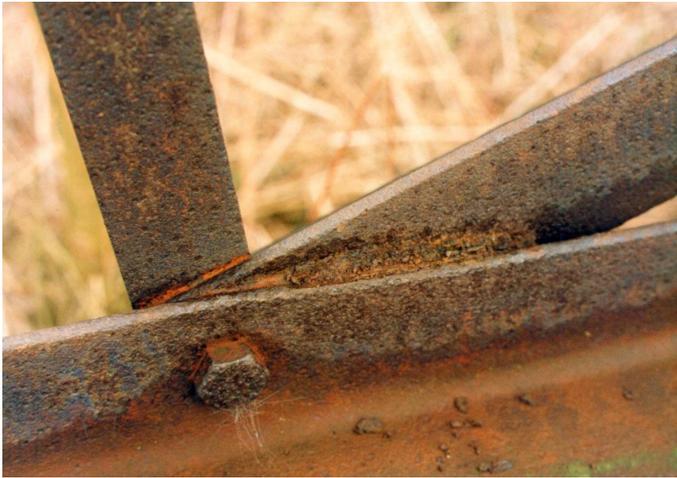
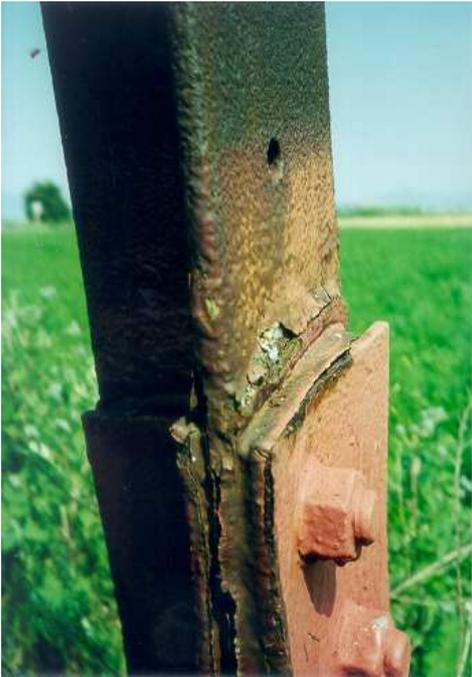
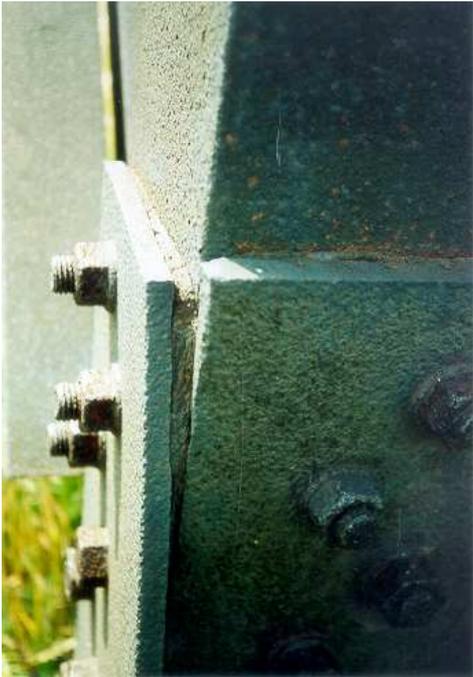
Annex A1

Examples of defects on inspected transmission towers

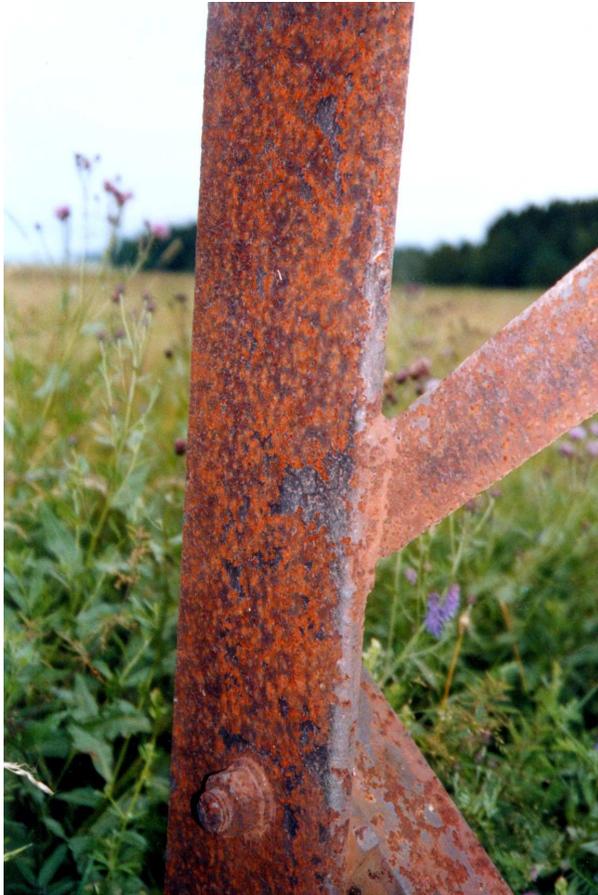
Rust layer on carbon steel

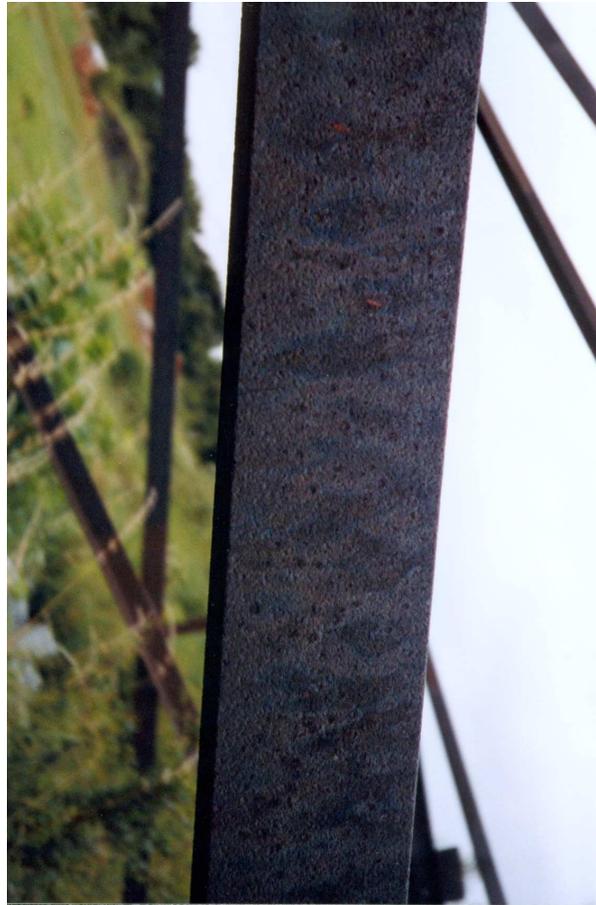
Protective patina on weathering steel

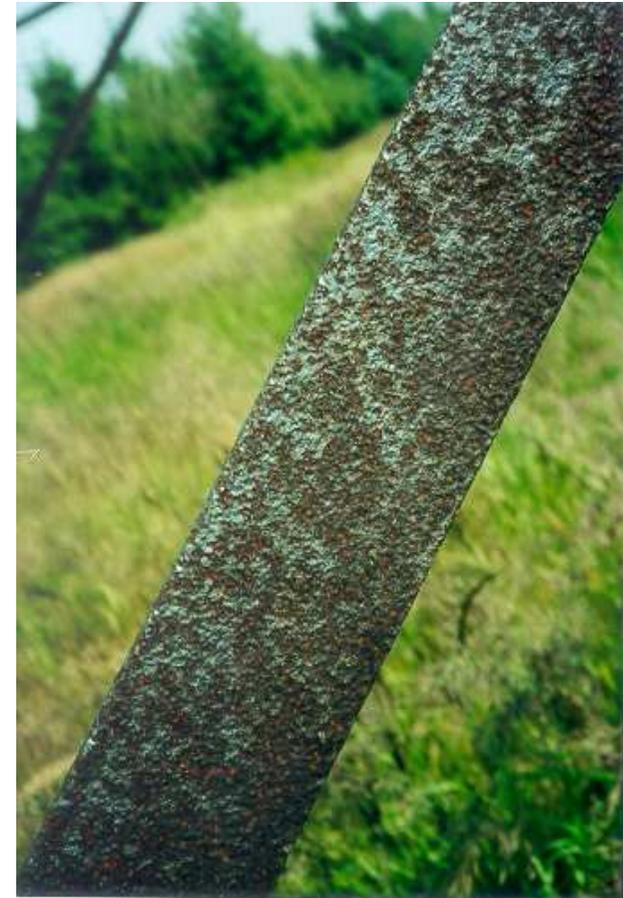
Less protective patina on weathering steel

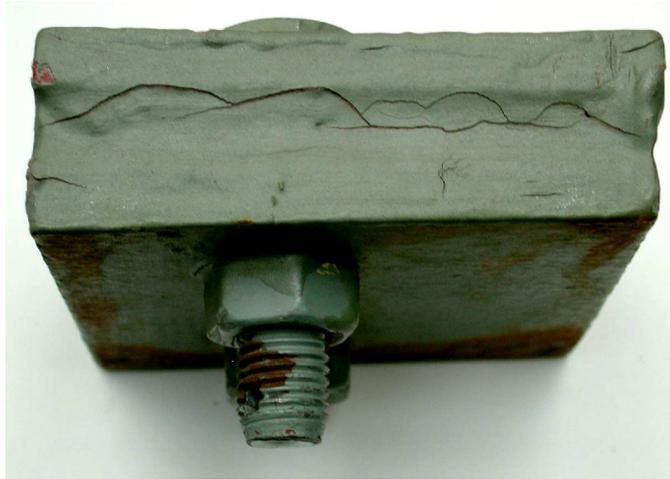
RPCS 1 - cracks in paint

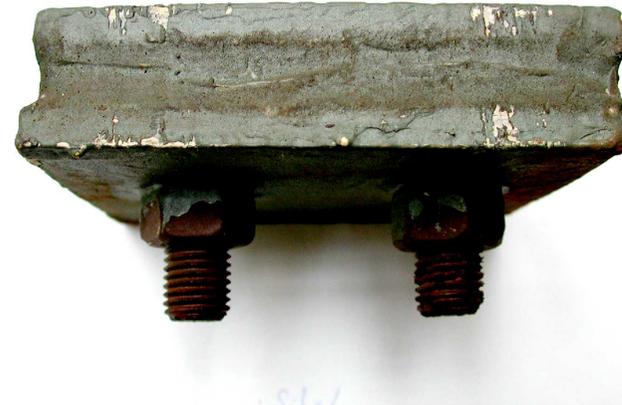
RPCS 6 - sticky surface

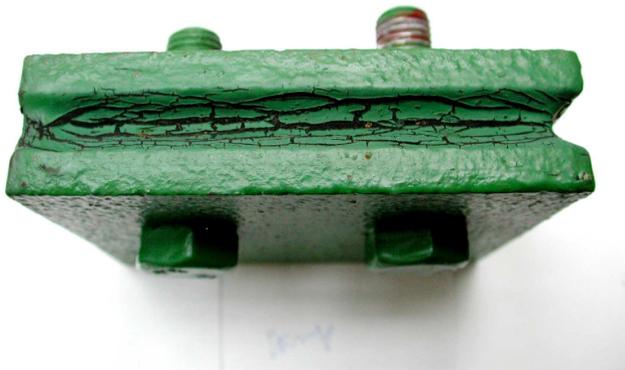
RPCS 10 - cracks in paint and cement

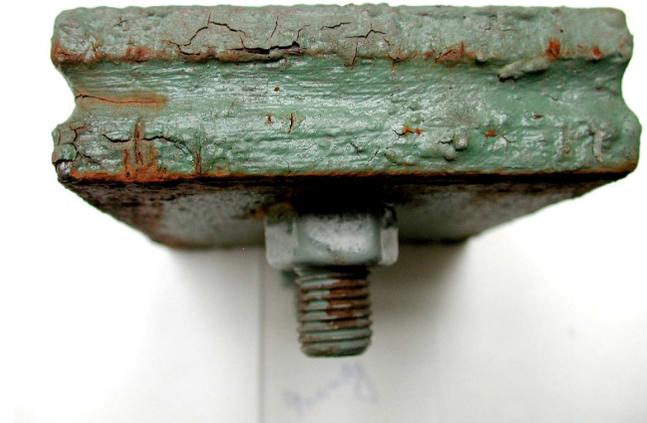
RPCS 11 - total deterioration of system

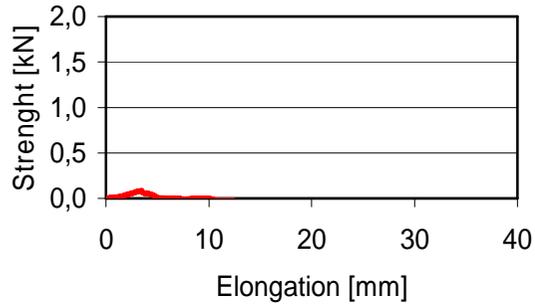
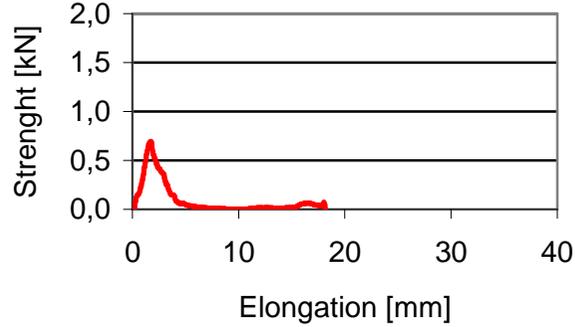
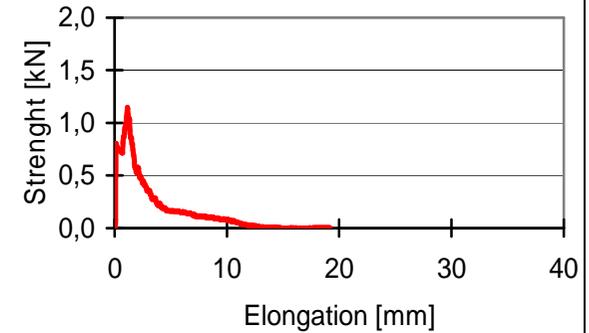
RPCS 3 - Better mechanical properties after environmental exposure, cement is getting stiff

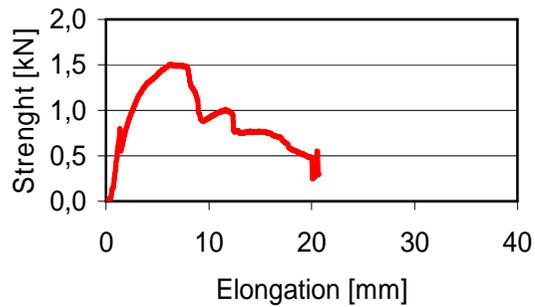
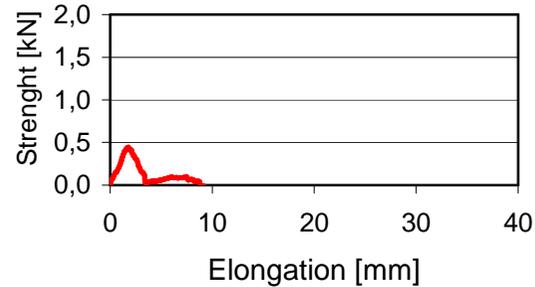
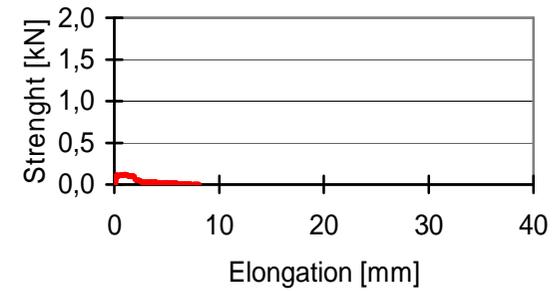
RPCS 5 - High drop of mechanical properties after environmental exposure

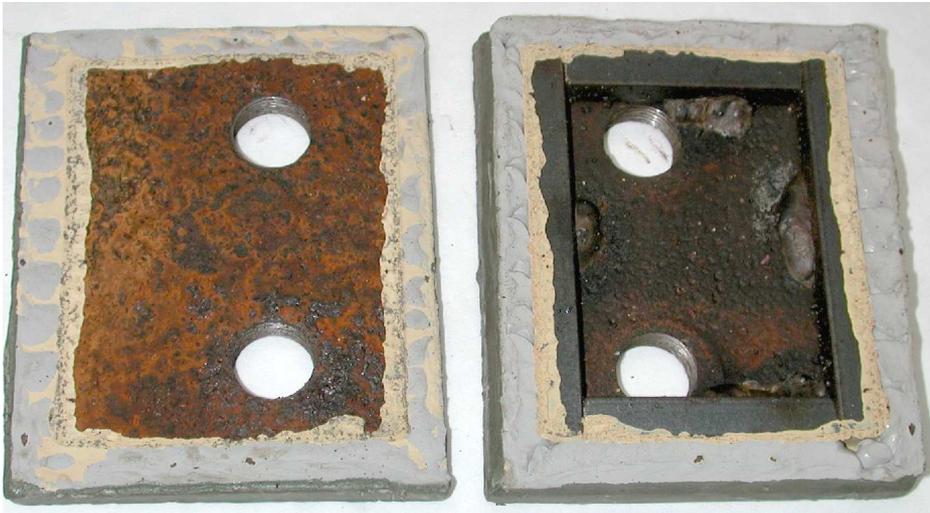
RPCS 6 - Acceptable performance

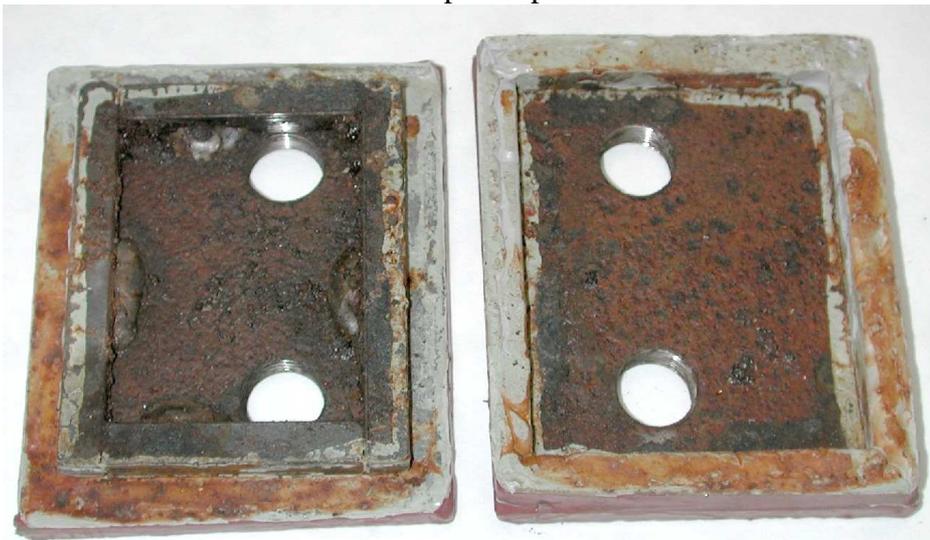
RPCS 8 - Rusting of interface of cement and steel

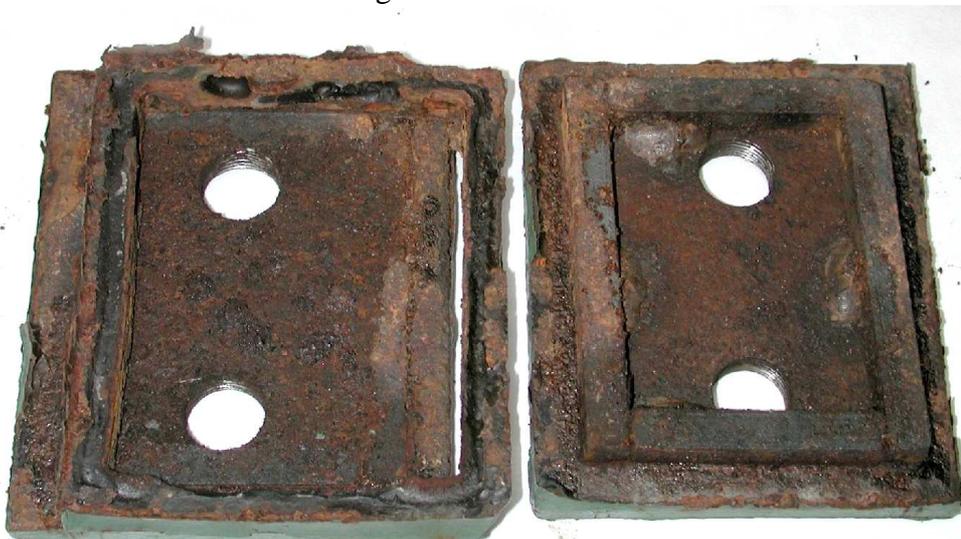
RPCS 11 - Total deterioration of system

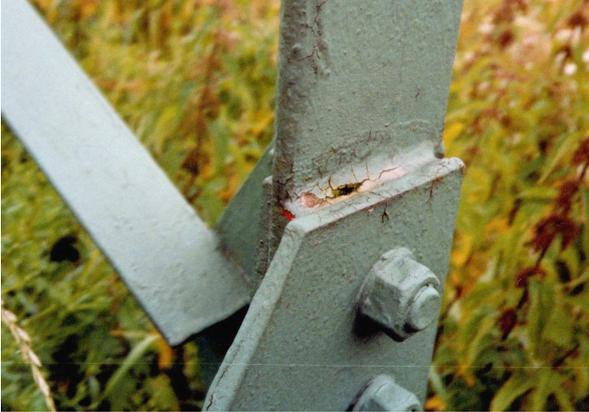
RPCS 10 - total degradation of system

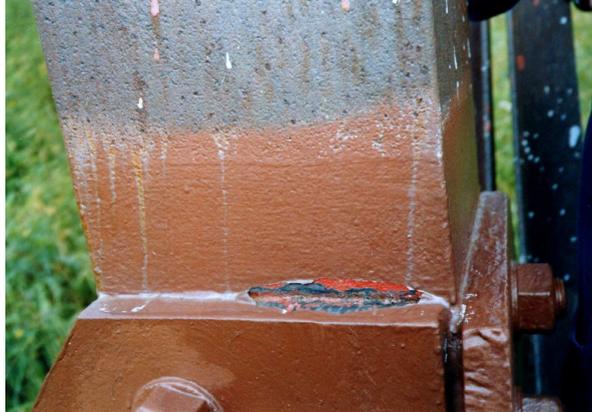
RPCS 10 - big blister in paint and cement

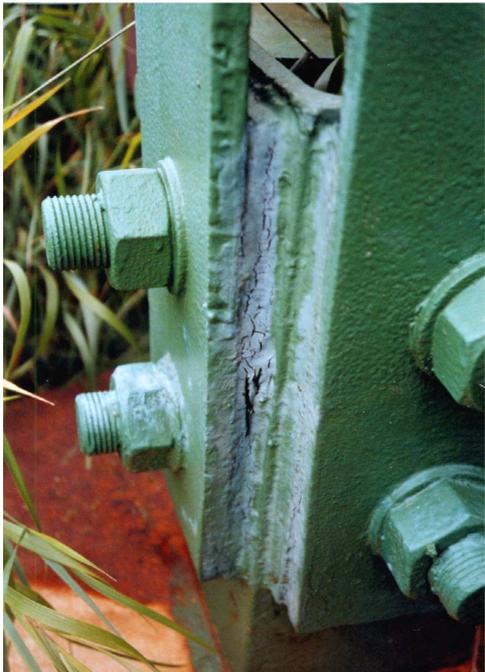
RPCS 10 - cracks in paint and cement

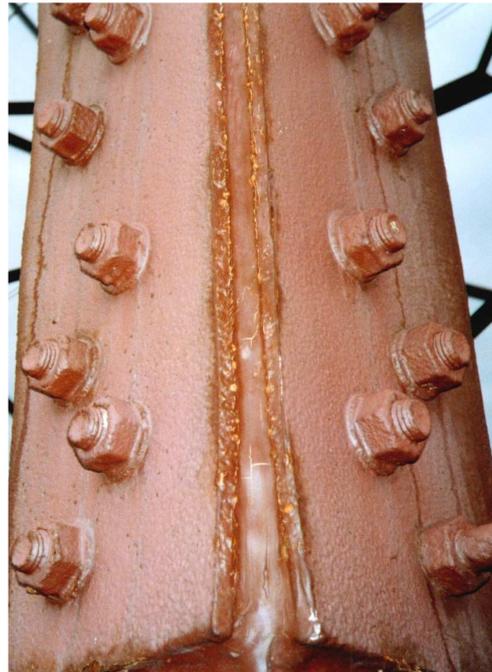
RPCS 8 - cracks in paint and cement
