# The effect of differentiated exposure conditions on corrosion behaviour of weathering steel on bridges

Corrosion attack on differentiated steel surfaces was quantified and properties of the patina layer evaluated. The contribution introduces examples of corrosion defects on weathering steel bridges initiated by both causes (effect of sheltering or design).

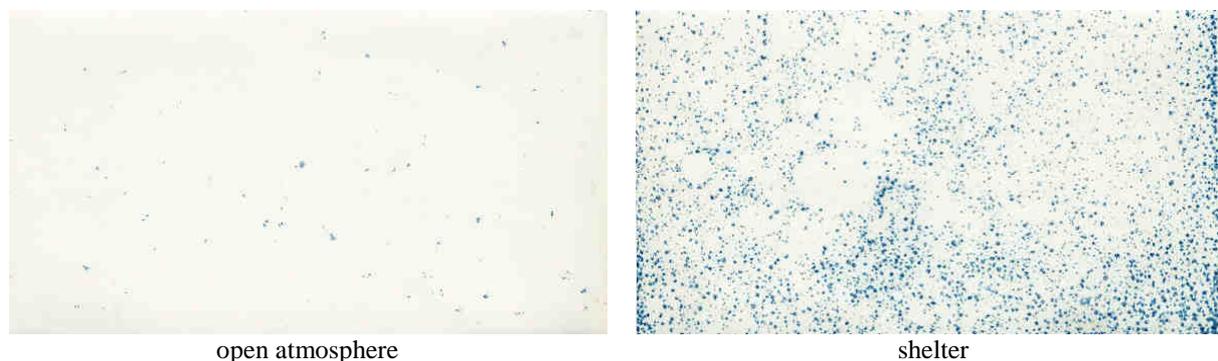
*Figure 2: Distribution of sulphates and chloride nests in rust layer after 8 years of exposure*

The basic information about corrosion behaviour of Czech weathering steel Atmofix 52A are derived from the results of long-term atmospheric exposures in various environmental conditions performed in periods 1968-1978, 1975-1986 and 1986-1995 (Table 2) [3]. The low steady state corrosion rate as result of protective function of rust-patina layer had been obtained in case the corrosion mass loss after 3 exposure years was lower than 500 g.m<sup>-2</sup> (ca 60 µm) [4]. Comparison of long-term exposure in the open and shelter conditions in atmospheres with high air pollution (industrial, marine) showed high corrosion rate of weathering steel in shelter conditions after longer exposures due to cumulation of corrosion stimulators on steel surfaces. In shelter conditions the non-homogenous rust layer formed which obtained higher concentration of corrosion stimulators (sulphates, chlorides) – Figures 1 and 2.

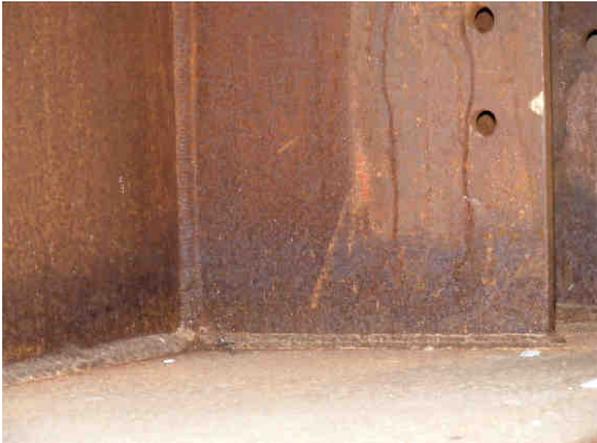
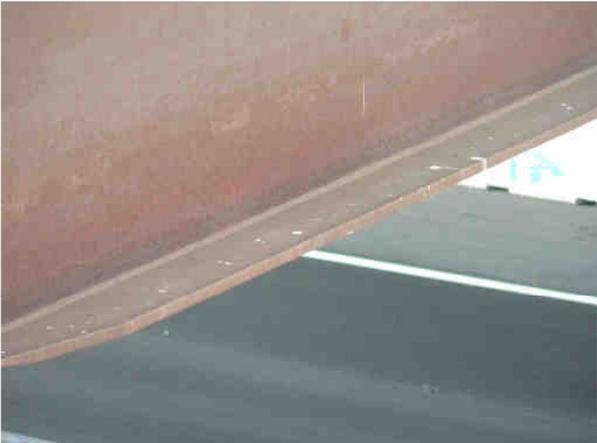
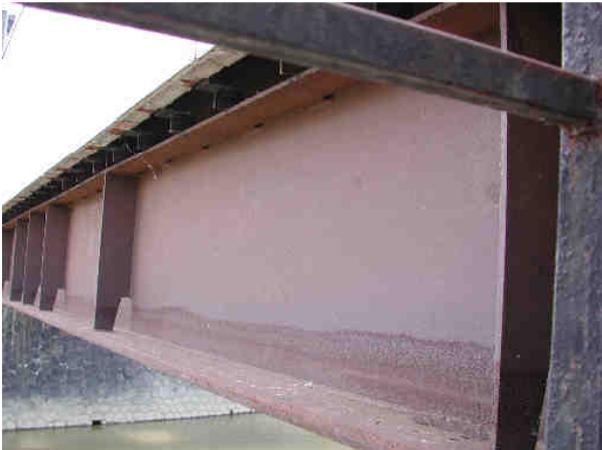
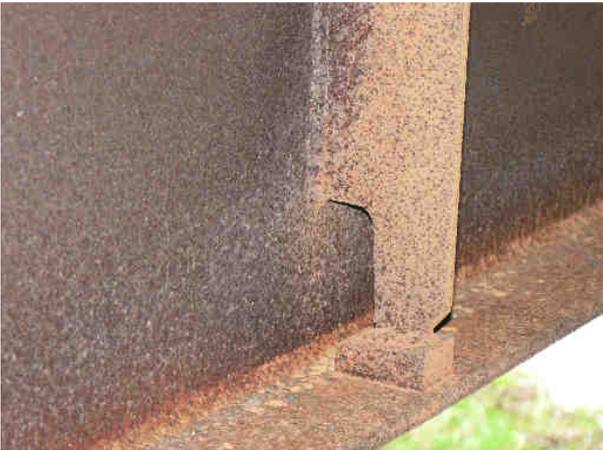
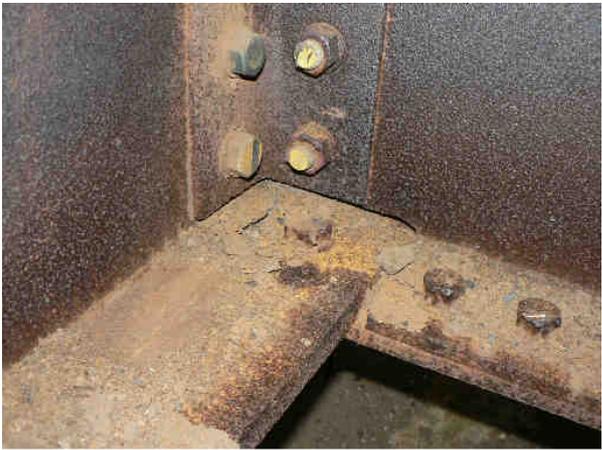
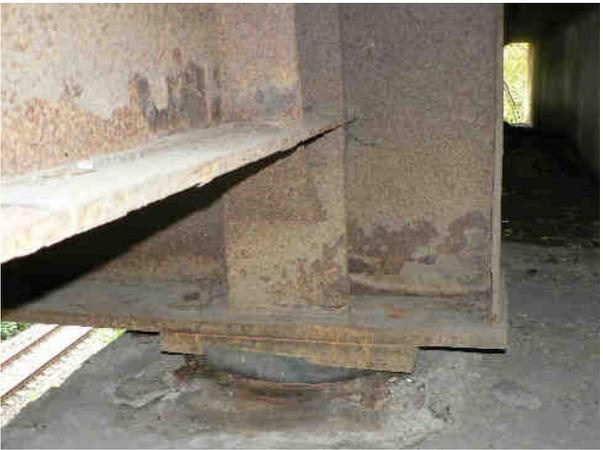
3 – 5 years exposed bridges

25 – 30 years exposed bridges

*Figure 4: Examples of rust layer above bottom flange*

This effect may develop only on real bridge structures. Corrosion of vertical and horizontal surfaces of bridge structures is slightly different. Critical areas are horizontal surface of bottom flange and narrow strip of web approximately 15 cm above this bottom flange where time of wetness of surface is longer and deposition of non-adherent rust, dust and other pollutions occurred there (Figure 4). On narrow strip above bottom flange the rust layer is less adherent than on typical open surfaces but it does not mean that this rust layer has not protective ability. The most critical is this effect on bridge surface located under plate where it is combined with sheltering effect [5].

The above mentioned areas had been evaluated on 3 bridges exposed for 25 – 30 years. The thickness of rust layer was measured (Table 4). Difference of residual thickness of steel profiles in vertical surface and surface 5 cm above bottom flange was detected as 5%.

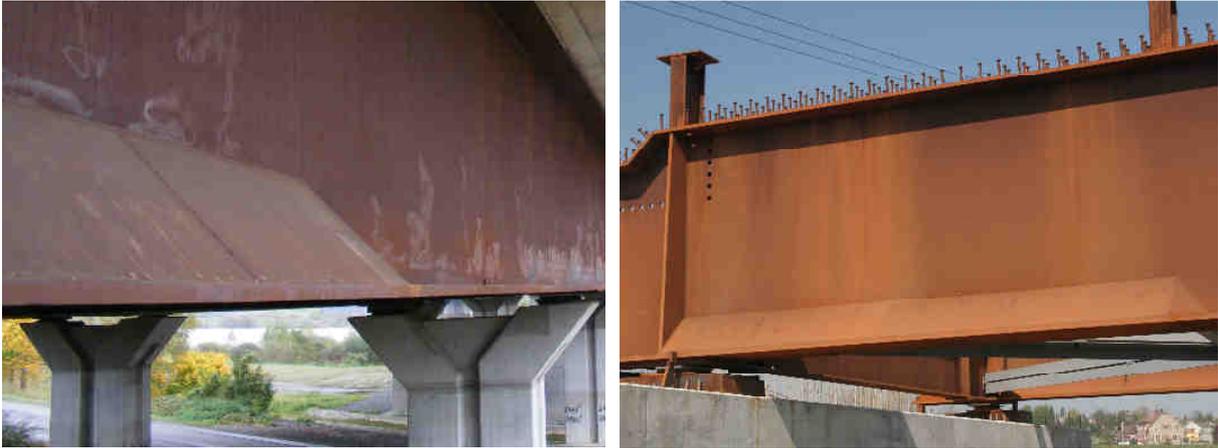
*Figure 5: New design of low flange element*

To eliminate this negative effect the application of special element was use to overlap critical surface of low flange (Figure 5). This slopping strap was used around bridge supports to prevent entrance of unathorized persons onto bridge structure. The structure design element is now used alongside the low flange for new planned high-way bridges in the Czech Republic [6].

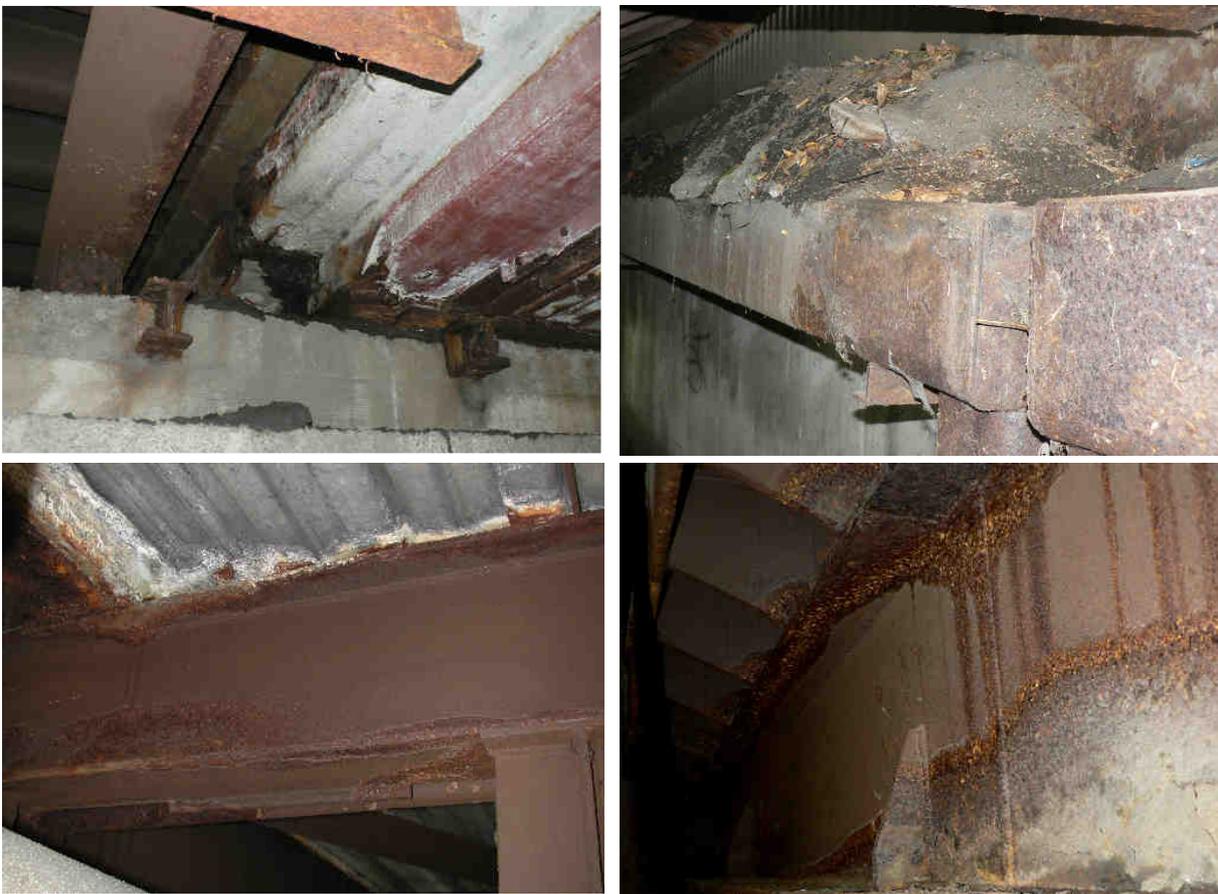
*Figure 6: Effect of leaked precipitation with de-icing salt content*

Negative effect on protective layer forming has such detail as deck drainage system (scuppers, troughs, etc.). During the inspection of bridges it were found many defects caused by these functionaless, blocked or trimmed elements (Figure 6). In these cases precipitation containing de-icing salts leaked on weathering steel surface and destroyed the protective ability of patina layer.
