The effect of differentiated exposure conditions on corrosion behaviour of weathering steel on bridges

Katerina Kreislova¹, Dagmar Knotkova¹, Vit Krivy², Jitka Podjuklova³

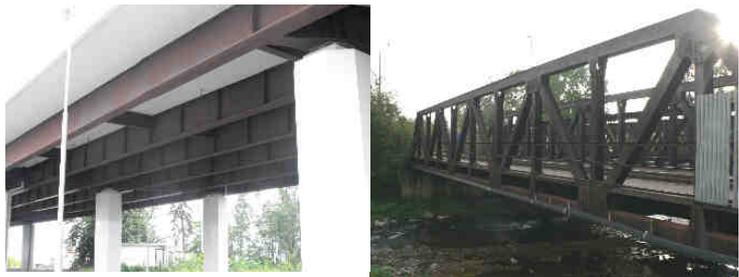
Figure 1 - The examples of evaluated bridges

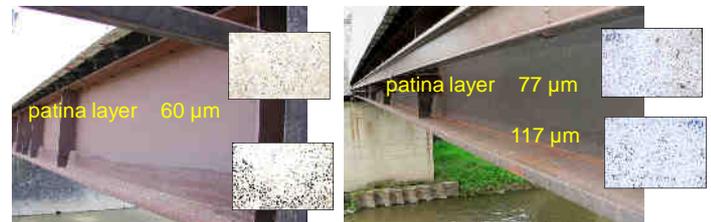
Corrosion attack of vertical and horizontal surfaces is different (Figure 2). Critical areas are horizontal surface of low flange and narrow strip ca 15 cm above this flange where time of wetness of surface is longer and deposition of non-adherent rust, dust and other pollutions occurred. The rust layer is less adherent on these areas than on typical open surfaces but it is protective. This effect becomes less significant during exposure time (Figure 3).

Figure 3 – The specific affected areas above low flange – the same bridge evaluated in 2002 (left) and 2009 (built 1986)

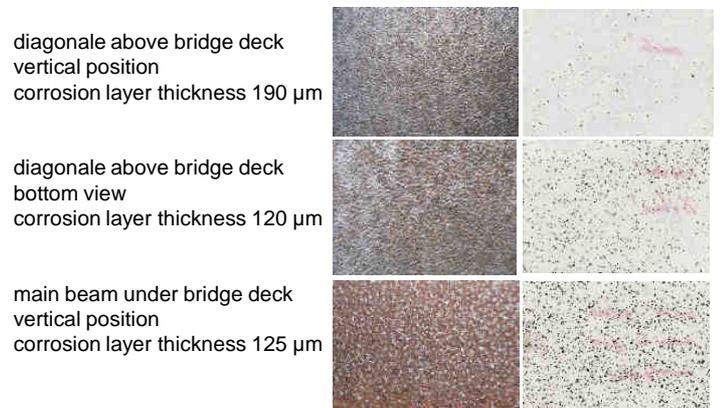
Rust layers reprints document the structure and compactness of patina layer (Figure 4).

Figure 4 – The different structure of patina layer on bridge after 30 years of exposure
